CE-05-63
June 28, 2005

SPECIAL AIRWORTHINESS INFORMATION BULLETIN

(a) No.:	13
(b) Revision / Date	Revision 0 / Date 29/10/04
(b)Title:	Cracking of Weld on Triple and Quad Burner Mountings.
(c)Description:	Possible failure of weld at joint between the burner can support plate and mounting tube.
(d)Applicability:	All Shadow, Stealth and Stratus Triple/Quad Burner assemblies with gimballed burners
(e)Effectivity:	All

ATA 28 - TRIPLE AND QUAD BURNER SUPPORT – INSPECTION

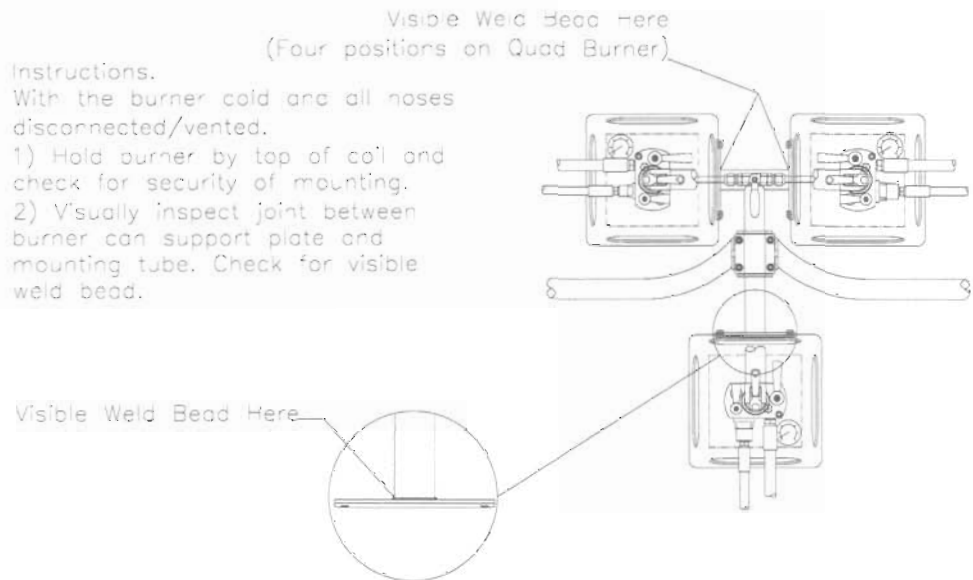
10. Figure 1:

There have been a number of failures during road transport of the weld between the burner can support plate and mounting tube due to insufficient weld bead/fatigue.

Bracket With Correct Weld Bead

Inspect burner mounting bracket for security and correct appearance. Refer to Figure1. Non-conforming/cracked brackets must be replaced. Exchange brackets will be provided together with an instruction sheet for local replacement, or the burner can be returned to the factory. Refer to Cameron Balloons Ltd. for details.

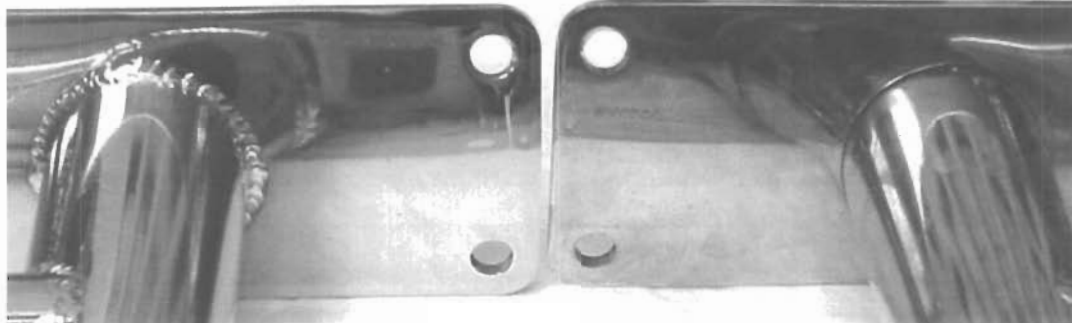
Bracket Without Correct Weld Bead
